# DOE/NASA TECHNICAL MEMORANDUM

DOE/NASA TM-78179

## FINAL REPORT ON MSFC ASSESSMENT OF OWENS-ILLINOIS SUNPACK<sup>TM</sup> COLLECTOR PROBLEMS

National Aeronautics and Space Administration  
George C. Marshall Space Flight Center, Alabama

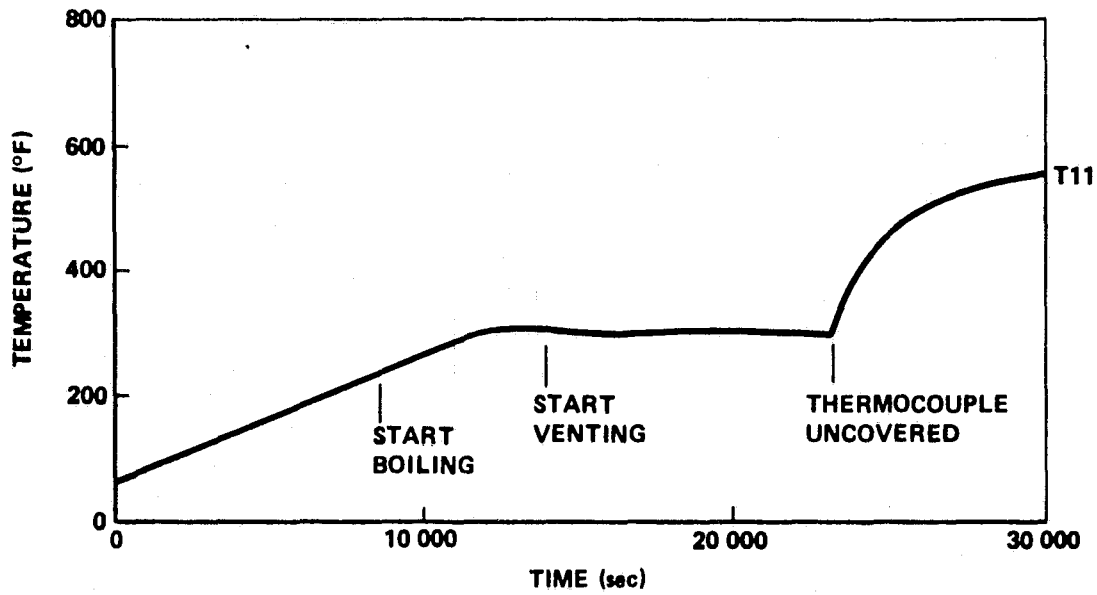
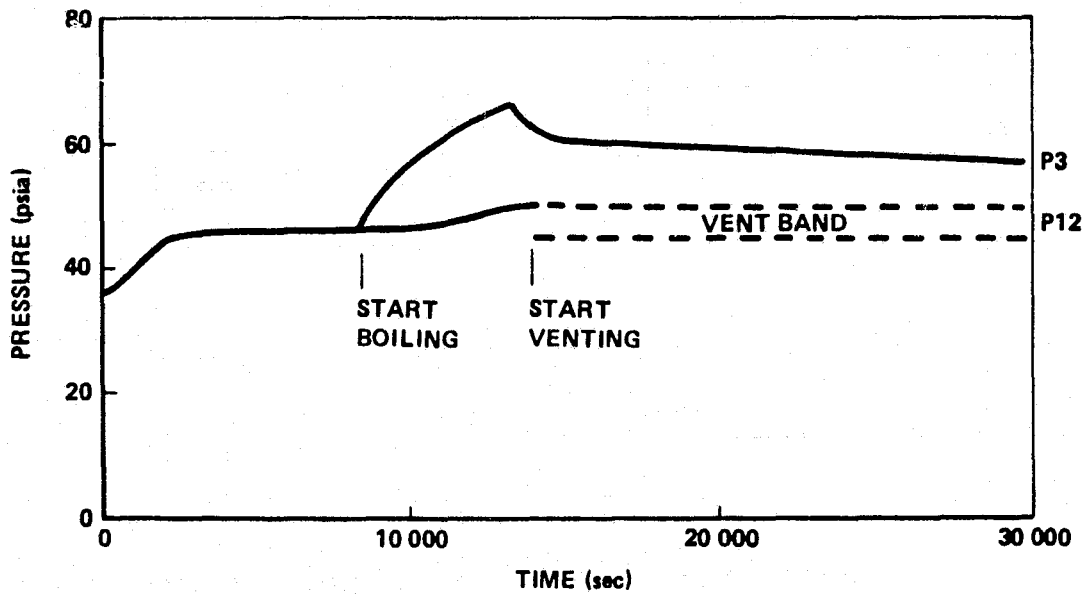
Typical first day boilout temperature and pressure data are shown in Figures 7 and 8, respectively. After boiling and venting action began, the water level in each tube, as observed in tests of slotted tubes, fell to levels determined by pressure and temperature in each tube. Above the water levels, temperatures rose to stagnation levels as shown in Figure 7 after thermocouple T11 was uncovered. Figure 9 is a plot of the pressure gradient across the upper tubes with time as a parameter. Except for temperature variations in each tube due to coating differences and simulator illumination nonuniformity, the water level gradient, like pressure gradient, decreased uniformly from inlet to outlet tubes. During first day boilout, no unexpected thermodynamic phenomena were observed and no tube breakage occurred.

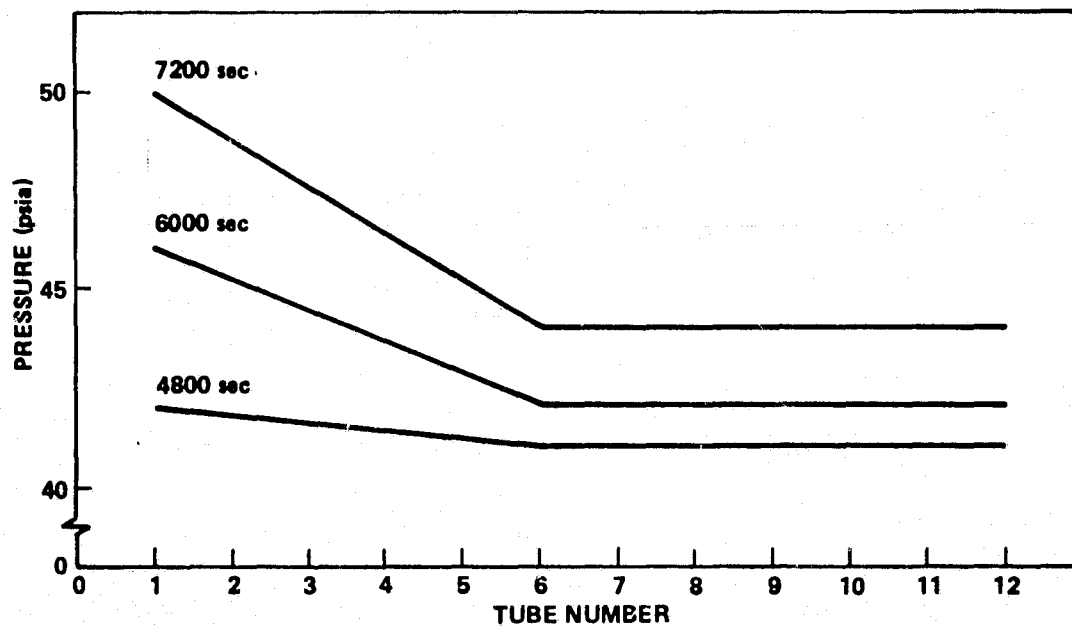
Figure 10. Pressure profile for collector tubes during a typical second day boilout.

Figures 10, 11, and 12 show typical data from second day boilout tests. From the character of the pressure gradient in Figure 10, one can conclude that water had backfilled tubes 1 through 5 leaving tubes 6 through 12 empty prior to start of second day boilout. This was observed in tests with slotted tubes as well as the fact that venting after boilout began did not redistribute water from the full tubes to the empty tubes. Hence, the percolating of boiling water does not occur to cause thermal shock and violent fracture of the absorber tube. Also, Figure 11 shows no glass breaking pressure surge when venting begins as one might expect if water were to move from a full tube into an empty tube which had reached stagnation temperature before the initial vent. Figure 12 shows there was not sufficient water in the collector after the first day boilout to completely backfill tube No. 5. Temperature at this upper thermocouple reached stagnation before the first vent occurred where the temperature at the same location in the full No. 1 tube was that of the boiling water. At the first vent, the stagnant portion of the partially full tube is cooled slowly, again indicating no large transfer of water onto the hot surface. During all second day boilout tests with good tubes, unexpected thermodynamic phenomena were not observed and no tubes broke. Hence, one can conclude that good tubes will safely withstand the simulated boilout conditions.

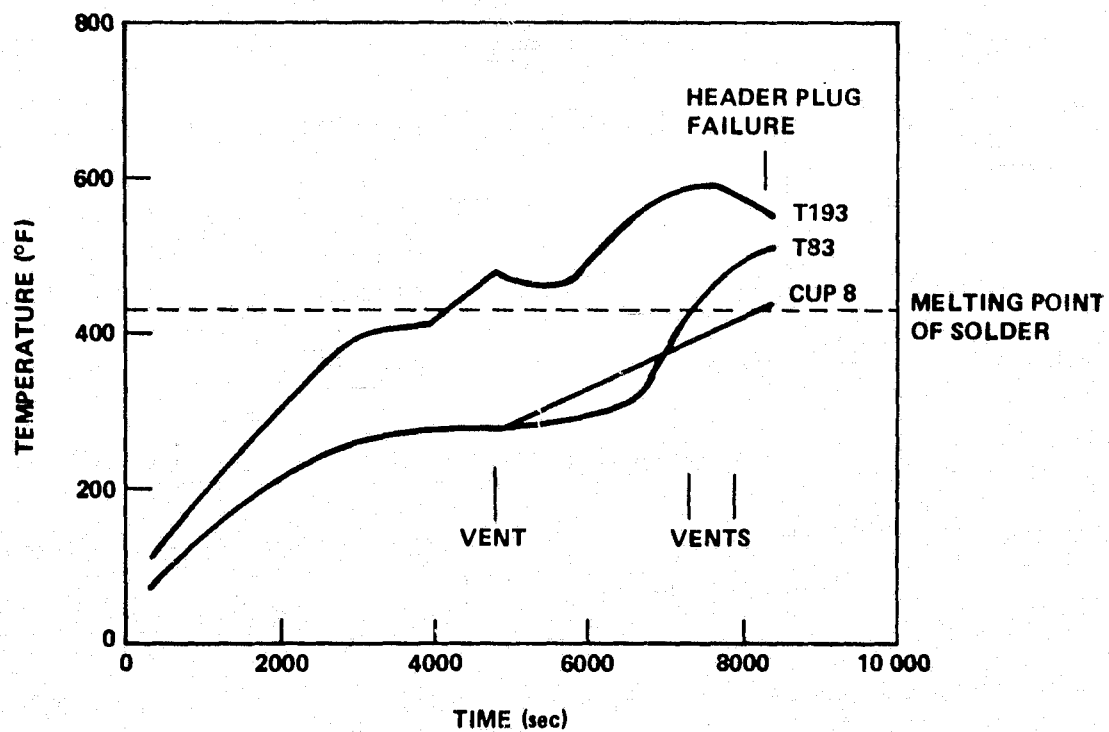
Figure 14. Temperature history of gradients through manifold for header plug failure.

The conditions which resulted in failure of the manifold solder can be understood from the temperature data shown in Figure 13 for tube cup 12 which is near the soldered manifold header plug that leaked in a second day boilout test. As venting begins, the temperature of steam passing through empty tubes at stagnation temperature begins a rapid rise. This temperature rise of steam is then similarly transferred to the copper manifold elements which interconnect the tubes. The time at which the melting point of solder is reached and failure occurred is shown. Figure 14 compares temperature of cup 8 to temperatures of the tubes upstream and downstream of the cup. The tube temperatures are those sensed by thermocouples located nearest the manifold.

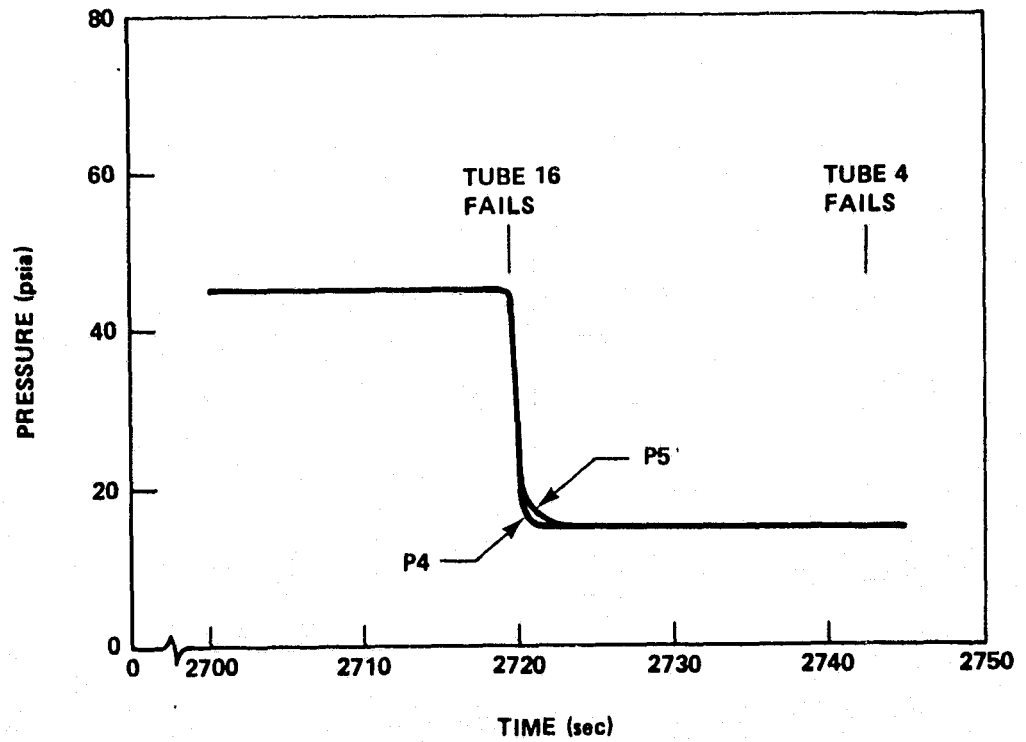
Figure 18. Pressure history when tube 16 failed.

Figures 15, 16, and 17 show the failed condition of the first set of scratched tubes after the collector had cooled to permit safe inspection. Violent fracture had occurred in tubes 16, 7, and 9; tubes 17 and 24 suffered secondary breaks from flying glass; and tube 4 had a passive ring-off in the inner absorber tube. The feeder tube is seen separated at the joint in tube 16 which fractured first. The rubber material used for this joint and tip protectors on the feeder tubes had been observed to soften and become putty-like after being subjected to temperatures of a second day boilout. It is not known if this separation resulted from the violent fracture, or caused the fracture by allowing the feeder tube to touch residual water which could then percolate up the tube to splash on the hot absorber tube. Pressure sensed at either side of the failed tube 16 is shown in Figure 18 and indicates no pressure surge before failure. Similarly, the temperature histories (Figs. 19, 20, and 21) for the failed tube and tubes either side of the failure indicate a stable condition at the time of failure.

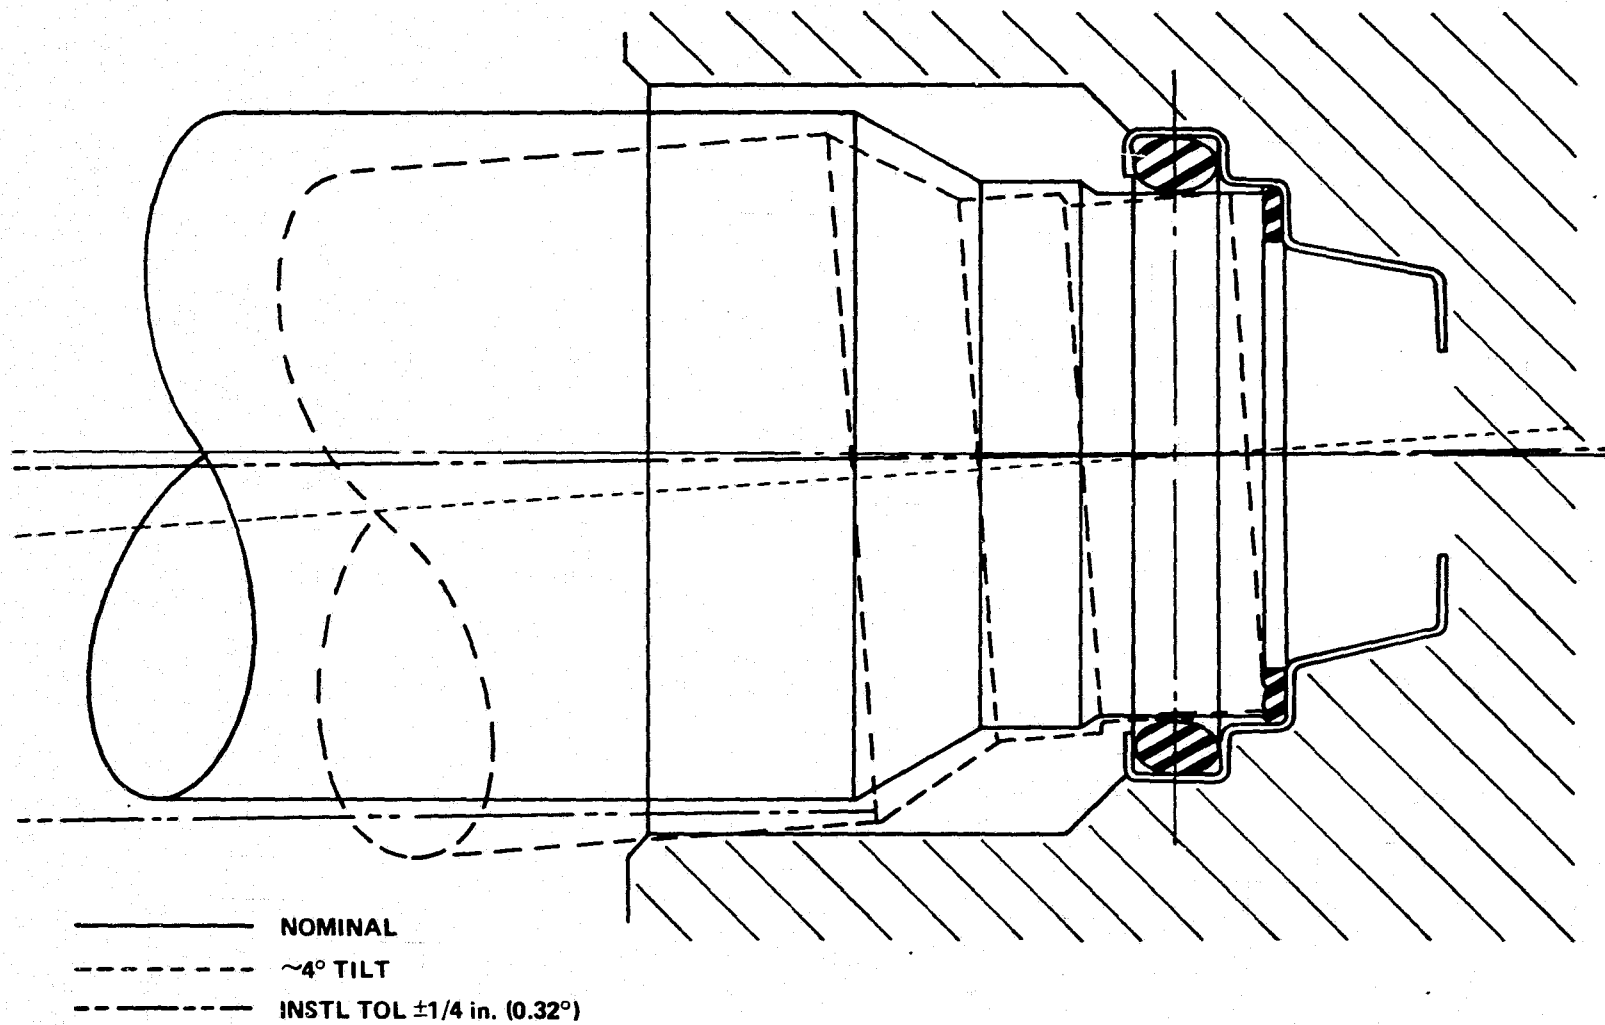
Figure 28. Alignment assessment.

The alignment study objective was to show that the tubes could not experience metal-to-glass contact in a binding condition as a normal situation. In all cases, worse-case tolerances were taken to ensure complete confidence in the outcome. Drawings of the tube, cup, and insulation were completed as shown in Figure 28. The normal maximum tolerance at the construction site is  $\pm 1/4$  in. deviation from the horizontal, which is equivalent to 0.32 degree. This proved to be a safe condition. The maximum deviation which the tubes could undergo without touching some member other than the O-ring or flat gasket was  $\pm 4$  degrees, equal to over 10 times the maximum on the installation drawings. At this point the tube could touch the outer edge of the insulation. The conclusion reached is that alignment tolerances cannot cause glass breakage.

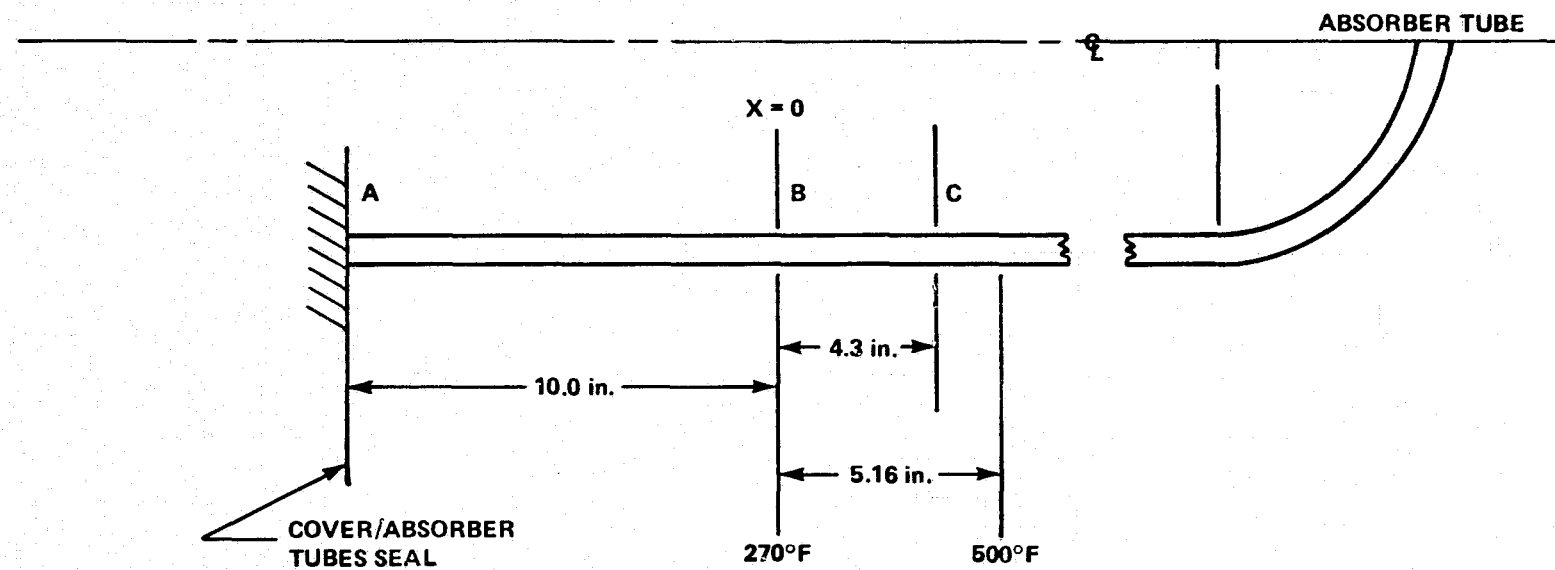
Figure 30. BOSOR — Finite Element Model of absorber tube.

Results from the BOSOR analysis are shown with the model in Figure 30. The maximum stress ( $S_{\text{von mises}} = 7410$  psi) occurred at the seal while the membrane stresses in the cylinder and dome of the absorber tube were small (approximately several hundred psi). The ultimate strength of the KG33 glass material is considered to be 10 000 psi which is based on ASTM testing of 3/8-in. diameter glass rods and therefore somewhat questionable due to the

difference in configuration. This value may be a little too high. Although this stress at the seal is considered conservative, there are still other unknowns in this area that should be determined to establish a valid margin of safety. These unknowns are residual stresses incurred during forming operations, more definitive temperature data in the seal area, and worse-case seal geometry.

Summarizing the strength analysis, it appears that the SUNPAK<sup>TM</sup> tube assembly is structurally adequate; however, the required margin of safety cannot be ascertained at this time without accomplishing the previously mentioned tasks. Also, defects such as scratches, pits, etc., cannot be tolerated, particularly in the absorber tube. It was proven in hydrostatic testing [2] that the tube assemblies were weakened appreciably due to scratches on the absorber tube. Visual examination of tubes that were subjected to hydrostatic testing confirmed the occurrence of flaw propagation. Due to the absence of fracture toughness data, flaw growth with respect to the intended service life of the tube assemblies cannot be assessed. Therefore, it is considered mandatory that the tubes be screened during manufacturing and hydrostatically tested to 350 psig to eliminate those containing defects.
